Manhole Inspection Summary

Manhole # S31C__035MH

Insp Date: **6/3/09 11:48 AM**

Location Address: **410 MULBERRY ST**

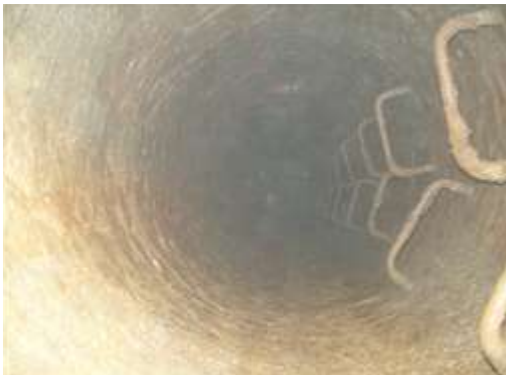
Defect 2

☒ **Evidence Of Surcharge**

Depth: **11** (ft.) ☐ Active Surcharge Present

evidence of ASUR

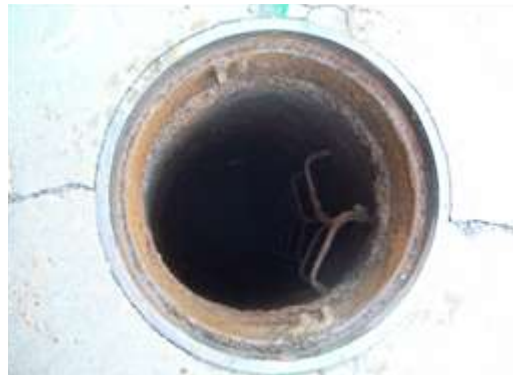
Defect 1

Count: **32** Missing: **0** ☒ **Corroded**

CORRODED STEPS

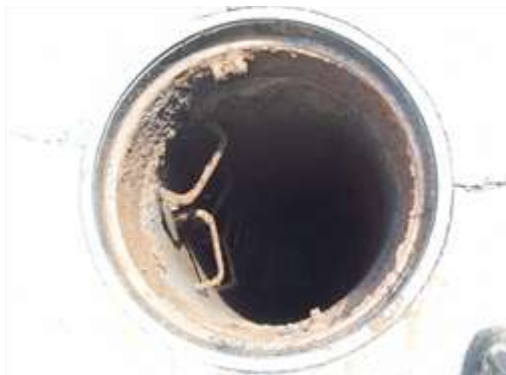
Defect 3

frame cracked

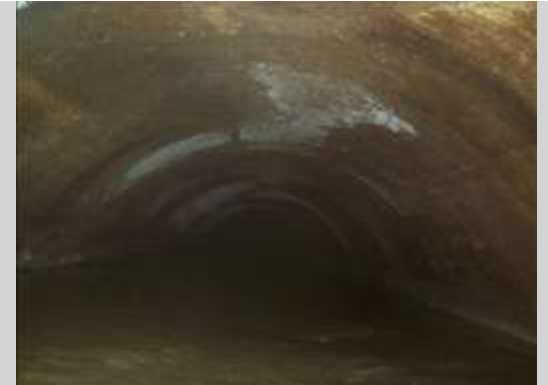
12 O'Clock Outflow

72 in. Circular Gravity Sewer
Pipe Out @ 12 O'Clock

Pipe Height: (in.) Direct
Pipe Material: **Concrete** ☐ Pipe Lined
Invert Depth: **33.30** (ft.) Flow Characteristics: **Slow**
Deposits: ☐ None ☐ Mud ☐ Sludge ☒ **Debris** ☐ Grease
Silt Depth: **12** (in.) Deposits Extent: **Light**
Infiltration: **None** Pipe Seal Cond: **Sound**

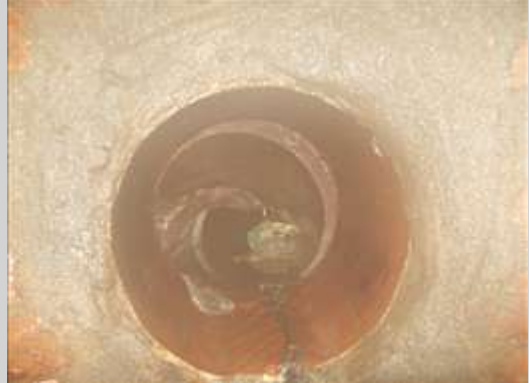
6 O'Clock Inflow

10 in. Circular Gravity Sewer
Pipe In @ 6 O'Clock

Deposits: ☐ None ☐ Mud ☐ Sludge ☒ **Debris** ☐ Grease

Silt Depth: **0** (in.) Deposits Extent: **Light**
